April 22, 2004

**RE: Pre-demolition Asbestos Inspection for former Inno Tech Industries located at 154 Olive Street in Elyria, Ohio 44035**

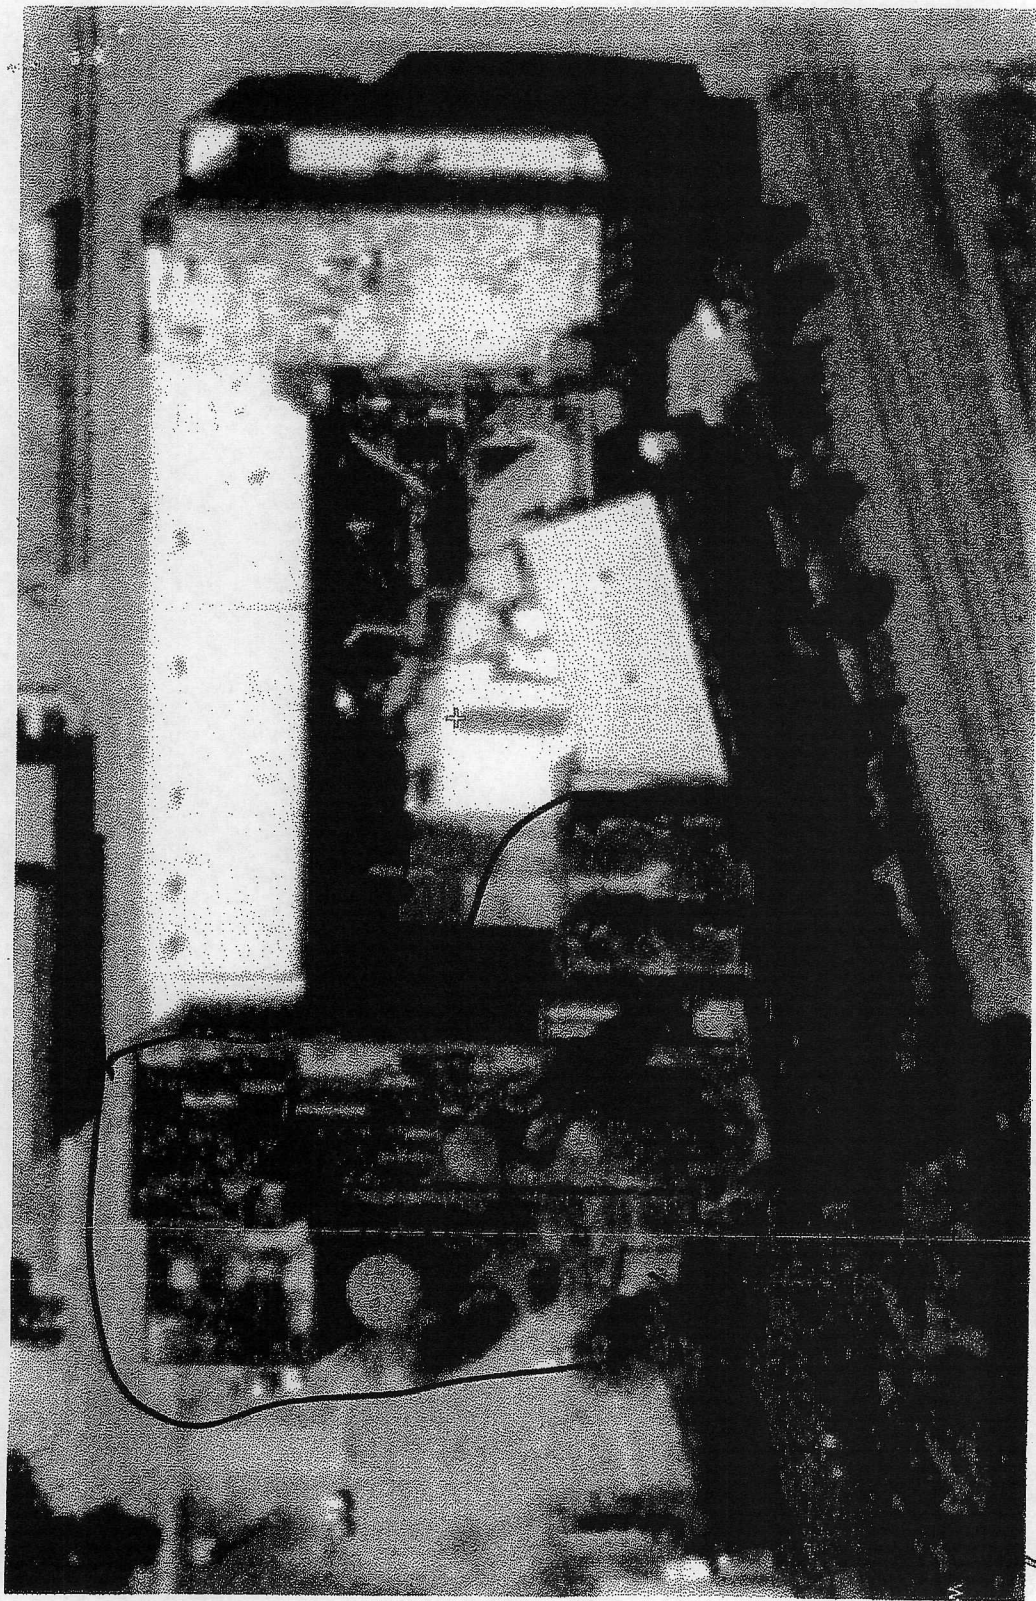
This is a photograph of the two pipe runs located in the courtyard area. Both of them were tested and contain asbestos in the insulation.
